To: Scott Schmid
Melanie Runkel
Clark County-Springfield Transportation Coordinating Committee

January 22, 2021

Subject: Scioto Street Safety Study

The goal of this study was to assess the pavement markings and signage and perform crash analysis along Scioto Street (US 36) from Locust Street to the SR 29/US 36 split in Urbana, Ohio. ODOT is resurfacing this segment of Scioto Street as part of the ODOT Urban Resurfacing Program. The striping changes and additional signage recommendations from this study will be included in the paving plans with the goal of mitigating crashes along Scioto Street.

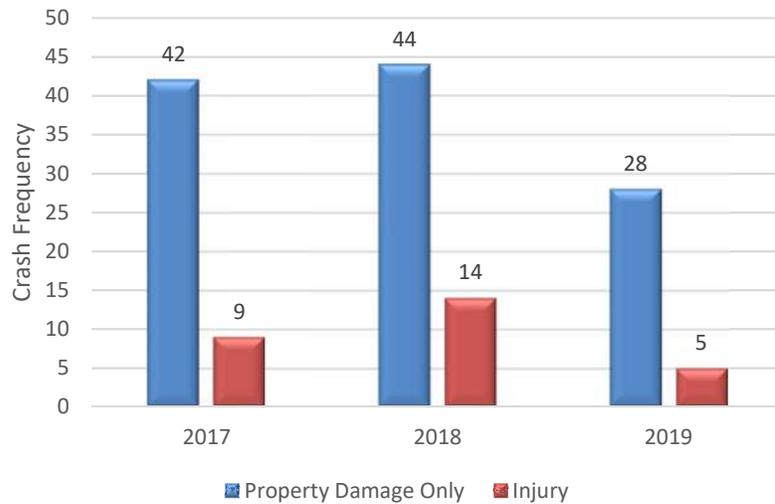
Figure 1: Crash Frequency by Year and Severity

Crash data from January 1, 2017 through December 31, 2019 was obtained for the study area using ODOT's GIS Crash Analysis Tool (GCAT) and analyzed using the Crash Analysis Module (CAM) Tool. The crash reports were opened and reviewed to verify to location of the crash and the crash type. A collision diagram that shows crash patterns by illustrating the approximate location of each reported crash is provided in **Attachment 2**. The output for the CAM tool is provided in **Attachment 3**. There were a total of 142 crashes with 28 (20 percent) resulting in injury. There were no fatalities in the study area and two serious injuries. **Figure 1** shows the crash frequency by year and severity. Both property damage only and injury collisions decreased significantly from 2018 to 2019.

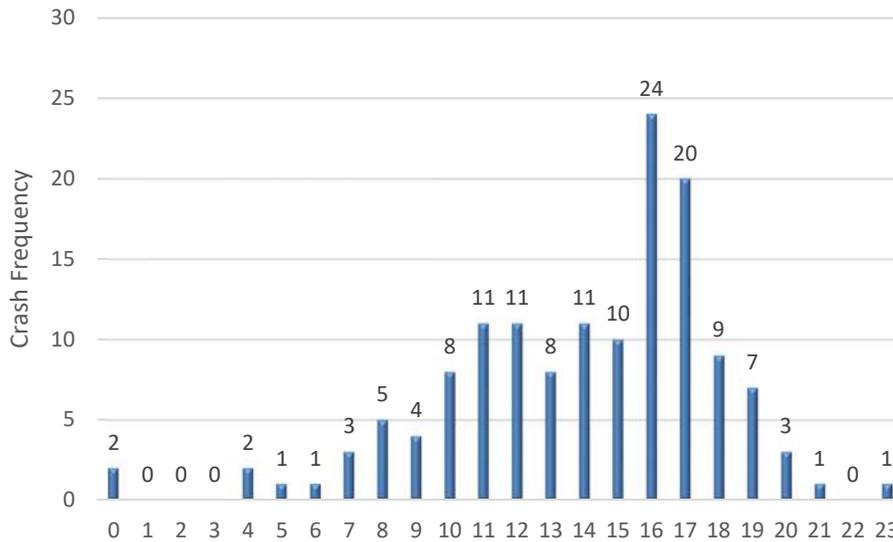
Figure 2: Crash Frequency by Hour of the Day

Figure 2 shows the crash breakdown by hour of the day. The highest crash frequency peak occurred between 4:00 PM and 6:00 PM (44 crashes).

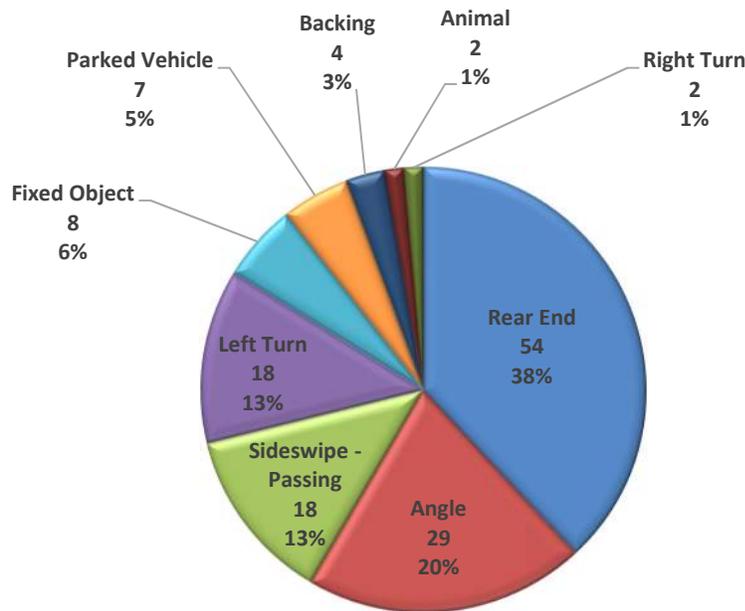
Figure 3: Crash Frequency by Crash Type

Figure 3 shows the crashes in the study area by crash type. Rear end collisions were the most prevalent crash type along Scioto Street (38 percent). 17 out of the 54 rear end collisions resulted in injury (31 percent). The crash patterns at each location along Scioto Street will be described in more detail in the following section.

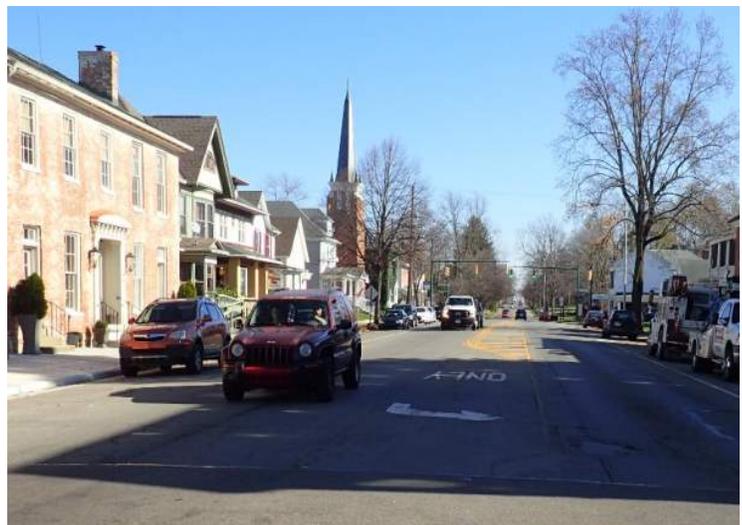
- The channelizing line for the westbound left-turn is worn and faded (**Photo 1**) which indicates some path overlap because of the lane alignment through the intersection.
- One fixed object collision was related to the intersection. This crash occurred when a semi-truck attempted to turn left into the south leg of the intersection and struck the building on the southeast corner.

Photo 1: Faded Channelizing Line at Locust St

- The westbound left-turn lane at Locust Street will be aligned with the pavement markings to the west.

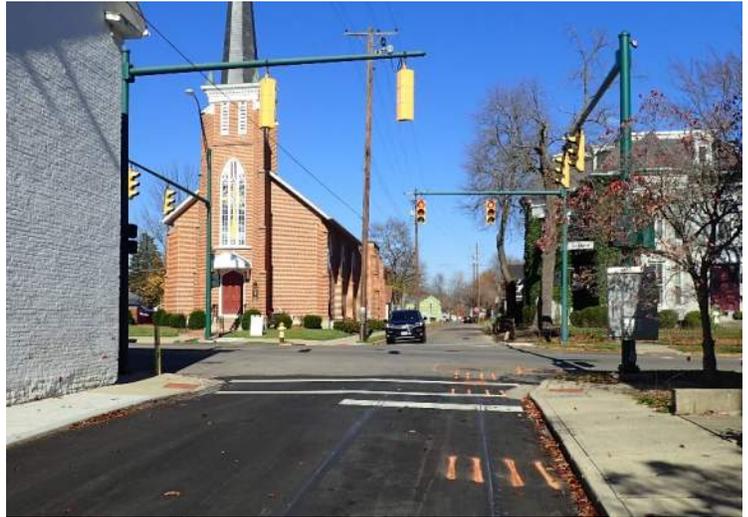
- Due to the tight radius of the eastbound right-turn and the narrow roadway, it is difficult for turning vehicles to avoid vehicles waiting at the stop bar on the south leg (**Photo 2**) of the intersection.
- Four rear end collisions occurred on the westbound approach, likely as a result of vehicles slowing or stopping in the through lane to turn left onto Kenton Street.
- Fixed object collisions were also a common crash type at this intersection. Two crashes occurred when vehicles struck signal poles and one crash occurred when a vehicle struck the building on the southwest corner.

Photo 2: South Leg of Scioto St and Kenton St

- Add left-turn lanes on both the eastbound and westbound direction. Adding these turn lanes would take away 97 feet of parking, which equates to approximately 4 parking spots on the east leg of the intersection. Parking would be unaffected on the west leg of the intersection.
- Relocate the stop bar on the south leg to be farther from the intersection and restrict right-turns on red on the northbound approach.
- While not part of the upcoming resurfacing project, adding backplates on all signal approaches is proposed to improve signal visibility.

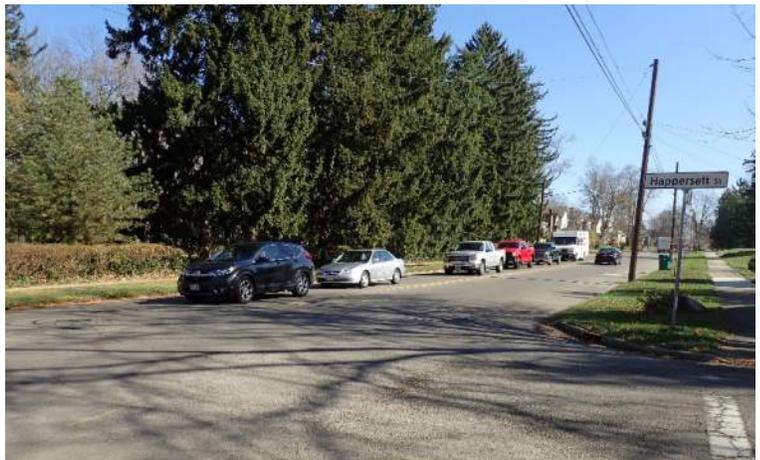
- When eastbound traffic is waiting to turn left on Scioto Street, vehicles are passing on the right due to the wide lanes.
- The main crash pattern at this intersection was westbound rear end collisions. This pattern is likely related to the queue that occasionally forms behind vehicles waiting to turn left onto Happersett Street (**Photo 3**).

Photo 3: Queued Vehicles on Westbound Scioto St

- The preferred option at this intersection is to add a westbound left-turn lane at Happersett Street. Adding the left-turn lane would eliminate 330 feet of parking or approximately 14 parking spots on the north side of Scioto Street.

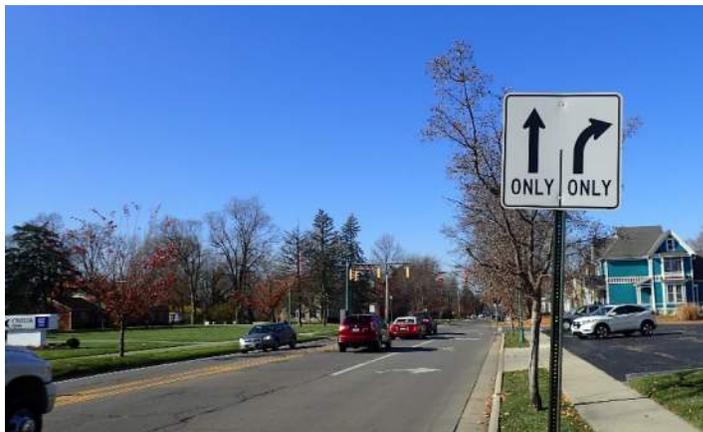
- It has been observed that some vehicles unfamiliar with the area (especially trucks) are not aware that the westbound right through lane becomes a right-turn only lane (**Photo 4**), so they abruptly change lanes before the intersection.
- Overall the pavement markings are misaligned through the intersection on Scioto Street, creating path overlap.
- The main crash pattern at this intersection is rear end collisions on the eastbound approach (four crashes).

Photo 4: Westbound Approach at E Lawn Ave

- Re-align pavement markings on both sides of the intersection.
- Extend the channelizing line for the westbound right-turn lane to the intersection of Patrick Avenue.
- Add a “Right Lane Must Turn Right” sign on the westbound approach.
- The following improvements are proposed to improve safety but not as part of the resurfacing project:
 - Add pedestrian signal heads and push buttons on the east leg.
 - Add backplates on all signal approaches to improve signal visibility.

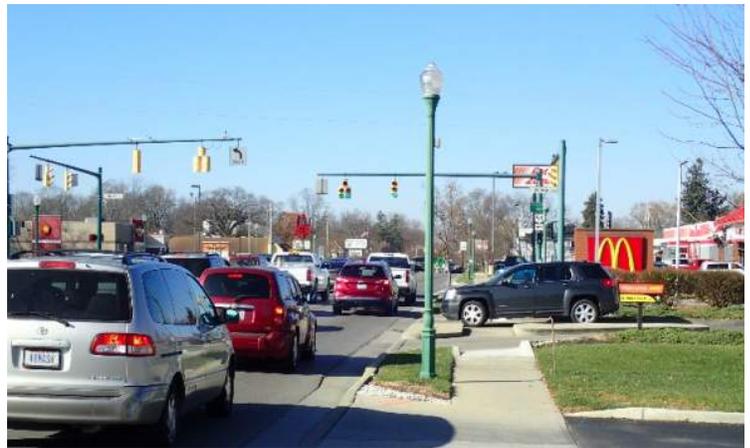
- Many drivers ignore the porkchop in the McDonald's driveway and turn left in and out of the driveway on Scioto Street (**Photo 5**).
- The striping of the TWLTL at the Pizza Hut driveway can be confusing to drivers as they attempt to turn left due to its close proximity to the westbound left-turn lane at Jefferson Avenue.
- The majority of crashes in this section of Scioto Street are related to various driveways along this section of Scioto Street. It can be difficult to accurately judge gaps in traffic due to the many vehicles entering and exiting the road from differing locations.

Photo 5: Vehicle Turning Left Out of McDonald's

- The following improvements are proposed to improve safety but not as part of the resurfacing project:
 - In order to solve the access management issues along Scioto Street, in the long-term an access management study is recommended to determine what driveways can be closed or if there is a possibility of constructing a backage road.
 - When new developments build in the area, they should comply with access management rules set by the City of Urbana.
 - Add backplates on all signal approaches of the Scioto Street and Finch Street signal.

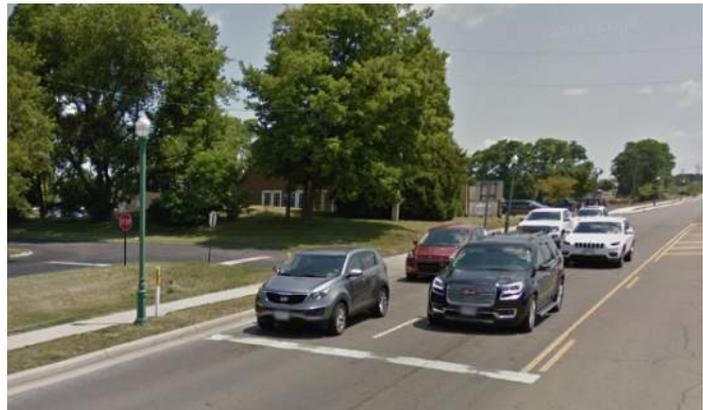
- At the eastern hospital entrance on Scioto Street, vehicles are delayed when turning left into the hospital since queued vehicles block the entrance (**Photo 6**).
- As some vehicles were turning left from SR 29, they were observed crossing into the TWLTL on the west leg (**Photo 7**).
- The main crash pattern at this intersection is north-westbound rear-end collisions on SR 29 as vehicles are approaching the signal. This is likely related to queuing on this leg of the intersection and inattentive drivers.

Photo 6: Queued Vehicles Blocking Driveway

- Add a “Right Lane Must Turn Right” sign on the eastbound approach.
- Add a channelizing line on the west leg between the through and right-turn lane.
- Re-stripe the eastbound TWLTL as an exclusive left-turn lane
 - Stagger the left-turn lane stop bar to prevent path overlap for left-turning vehicles.
- Add dotted pavement markings for northwest left-turning vehicles from SR 29 to indicate the appropriate path to drivers.
- Move the stop bar on the east leg upstream of the eastern hospital drive.
 - The initial stop bar will stay where it is with the addition of the new stop bar. Pavement markings and a sign will indicate that vehicles cannot block the intersection.
 - A sign on the east leg will indicate that vehicles traveling westbound have to stop at the “new” eastern-most stop bar.

- While not part of the upcoming resurfacing project, adding backplates on all signal approaches is proposed to improve signal visibility.
- In the long-term, the recommendation is to signalize the east hospital drive and add an eastbound left-turn signal phase.

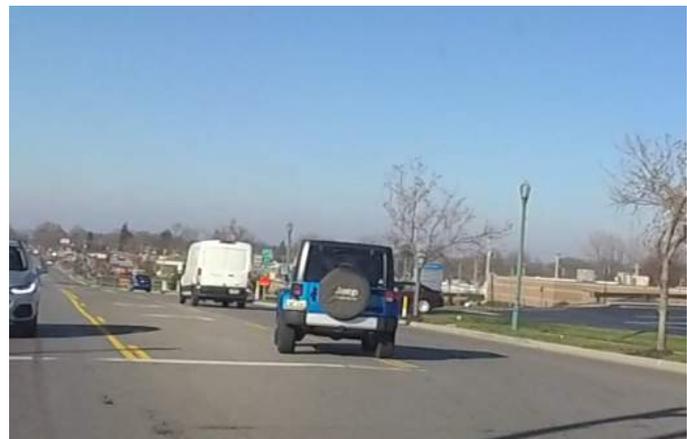
Photo 7: Northwest Left-Turning Vehicle Path
